# Estimation of Flooded Areas and Water Levels after the Heavy Rain in July 2018 in Okayama

**Abstract** Paddy fields in the Osaka Prefecture were heavily flooded by heavy rain in July 2018 due to levee breaches. To estimate the flooded area and water level, it was necessary to combine aerial- and ground-based surveying. Accordingly, aerial photographs of the flooded area were taken on the day after the heavy rain. In this study, we developed a digital surface model (DSM) of the flooded area using the structure-from-motion (SfM) software, which can produce three-dimensional (3D) models based on multiple aerial photographs and multiple ground control points (GCPs). Using the global navigation satellite system (GNSS), we surveyed the target area to observe the 3D coordinate values of the GCPs. The DSM of the flooded area could be made by the SfM with the aerial photographs and GCPs. The DSM was input into the geographic information system to analyze the flooded area and water level. The water levels were calculated from the differences between the DSM and the digital elevation model (DEM). We used airborne laser surveying to build the DEM because it provides higher accuracy than the

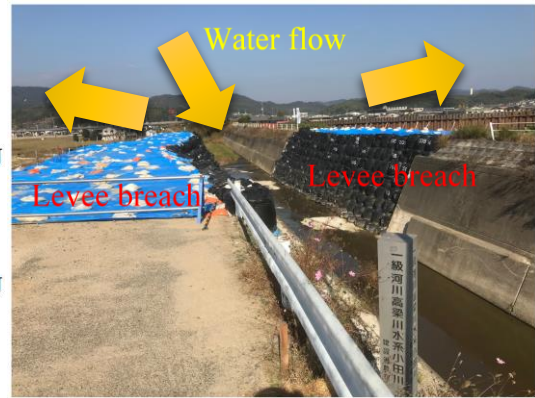
**Fig. 2 Levee breach at Oda River in Mabi City**

Figure 1 shows the target area of the survey and analysis. The Okayama Prefecture is located to the west of Osaka and Kyoto. Of the large area damaged by the heavy rain, we selected Mabi City to focus on the damage to paddy fields. Figure 2 shows the levee breach at the Oda river in Mabi City that caused the flooding of the paddy fields. The first author took the picture on November 10, 2018.

*The first author took the picture in November 10, 2018.*

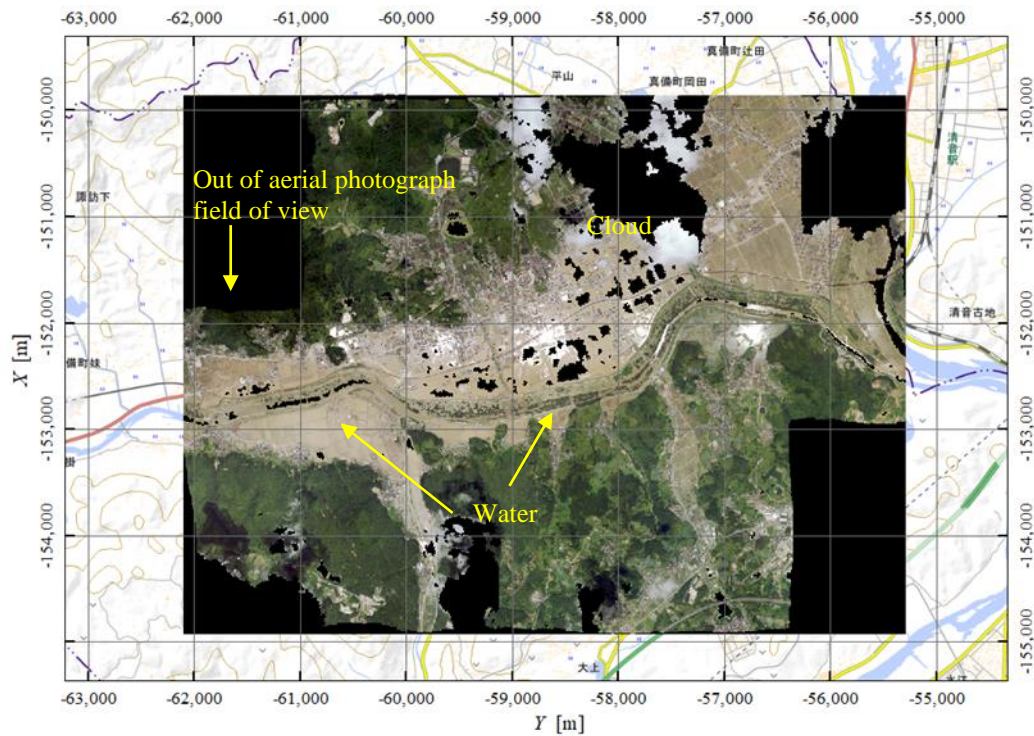
**Fig. 5 Orthophoto mosaic developed from the GIS**

Figure 5 shows the orthophoto mosaic developed on the GIS. For the aerial photogrammetry, we used the coordinate axis JGD2011 Plane-rectangular Coordinate System Area 5. The GIS software used was ArcGIS 10.7. By comparison with an existing map, we confirmed that the mosaic was developed on the designated positions correctly. The black areas in Figure 5 were either not in the aerial photograph field of view or covered by cloud or water, because SfM could not create the clouds and water. As shown in Figure 6, we successfully specified the exact positions of the levee breaches, and the orthophoto mosaic indicates that the paddy fields were flooded.

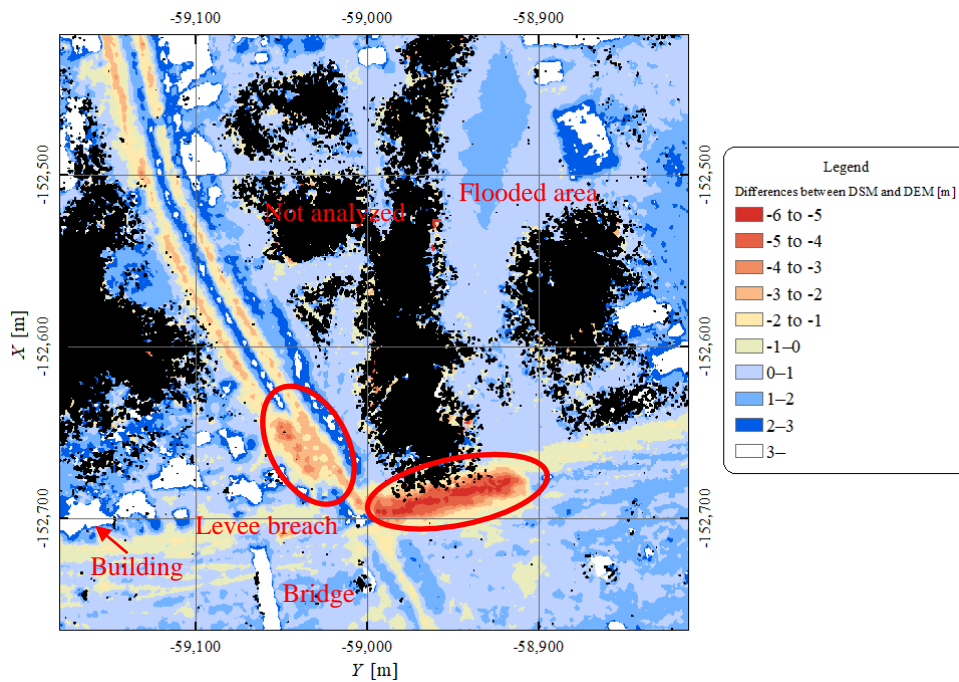
**Fig. 9 Differences between DSM and DEM**

To build the DEM before the heavy rain, we used the results (5 m mesh, elevation value in units of 0.01 m) obtained from the GSI. We deducted the elevation values of the DEM before the heavy rain from those of the DSM after the heavy rain to obtain the differences. Figure 9 shows the results of the analysis in the same area as that shown in Fig. 6. The black areas indicate areas for which the PhotoScan Professional software could not create the DSM. We whited out the objects with a height difference greater than 3 m because these were assumed to be buildings or vegetation. The analysis results indicate that the vertical water level was 0–2 m and vertical levee breaches levels were between -5 and -6 m. Based on the analysis of the differences between the DSM and DEM, we successfully clarified the vertical water level both dimensionally and quantitatively.
