Research article

Analysis on Surface Deformation and Cracks in Paddy Fields by 2016 Kumamoto Earthquake using GNSS and Photogrammetry

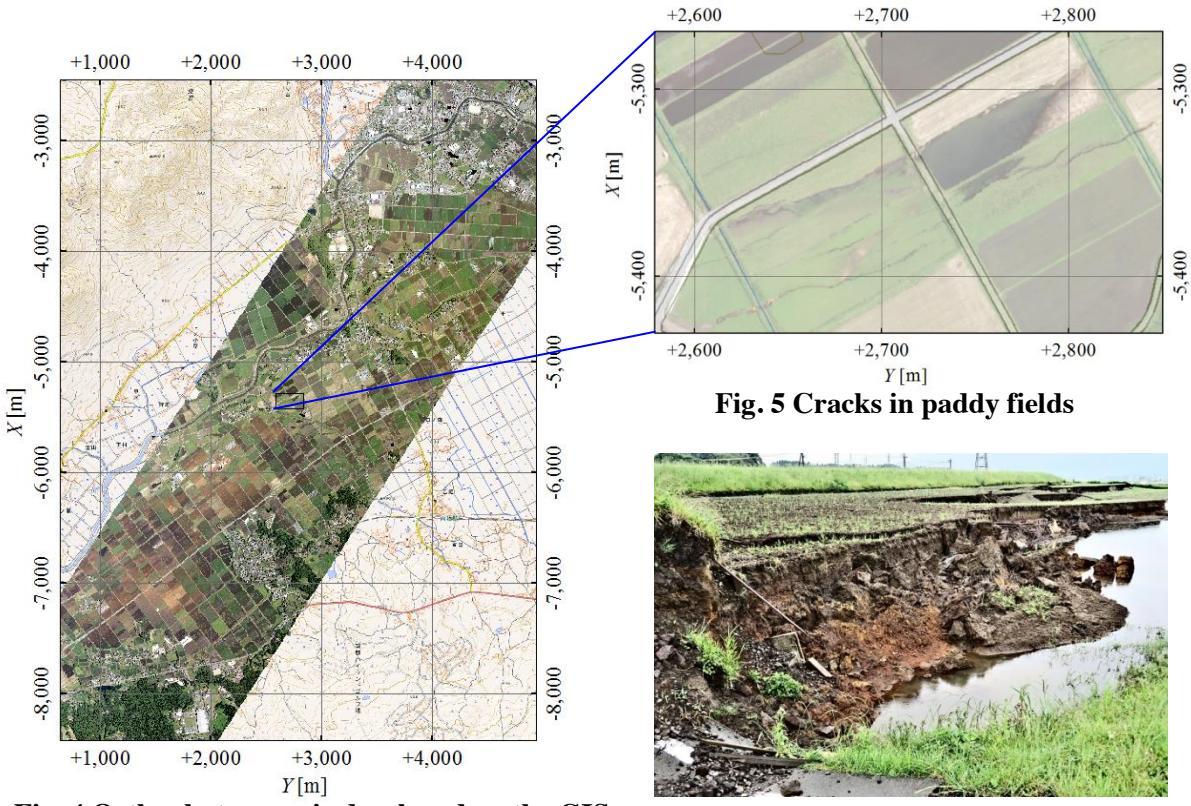
Fig. 4 Orthophoto mosaic developed on the GIS

Figure 4 shows the orthophoto mosaic developed on the GIS. For the aerial photogrammetry, we used the JGD2011 Plane-rectangular Coordinate System Area 2. The GIS software used was ArcGIS 10.4.1. We used the existing map as a background for confirmation of the positions. By doing this, we found that the created mosaic was developed on the designated positions correctly. The orthophoto mosaic indicates that this area consists of paddy fields. Subsequently, we set the transmission of the orthophoto mosaic at 50% and overlaid it onto the existing map to specify the positions of cave-ins. As shown in Fig. 5, we successfully specified the exact positions of the cracks. We were able to confirm cracks along the fault that occurred in the paddy fields. Fig. 6 shows a photograph taken by the second author of this study immediately after the earthquakes occurred in the area surrounding the paddy fields. It shows several cracks created along the fault. This visually confirms that there was a cave-in about 2 m deep.

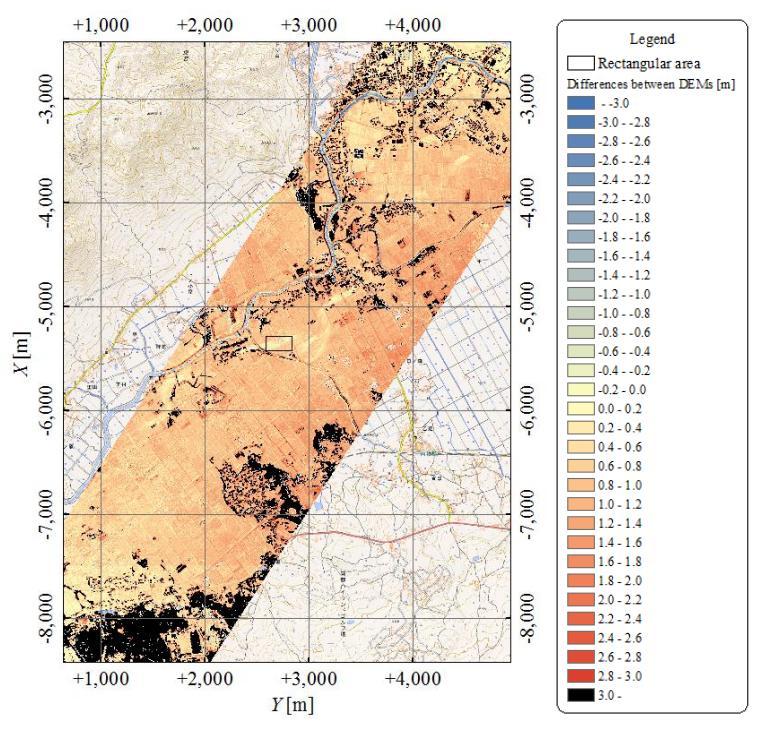
Fig. 7 Differences between the DEMs before and after the earthquakes

For the DEM before the earthquakes, we used the results (5 m mesh, elevation value in units of 0.01 m) obtained from the GSI. For the analysis of the difference between the DEMs before and after the earthquakes, we set the mesh sizes of the DEM before and after the earthquakes to 1 m. Fig. 7 shows the results of the analysis. We deducted the elevation values of the DEM before the earthquakes from those of the DEM after the earthquakes to obtain the differences. We blacked out the objects with a height difference greater than 3 m because these were assumed to be vegetation or buildings. The analysis results indicate that the area on which we focused underwent upheaval as a whole. When focusing on the agricultural roads, it was found that they underwent upheaval of 0.0–0.4 m. The paddy fields apparently underwent greater upheaval than the agricultural roads, but ambiguous places such as vegetation showed a low accuracy in matching. The rectangular part in the center of Fig. 7 is the cracked part shown in Fig. 5. Based on the analysis of the differences between the DEMs before and after the earthquakes, we successfully clarified the vertical deformation both dimensionally and quantitatively.

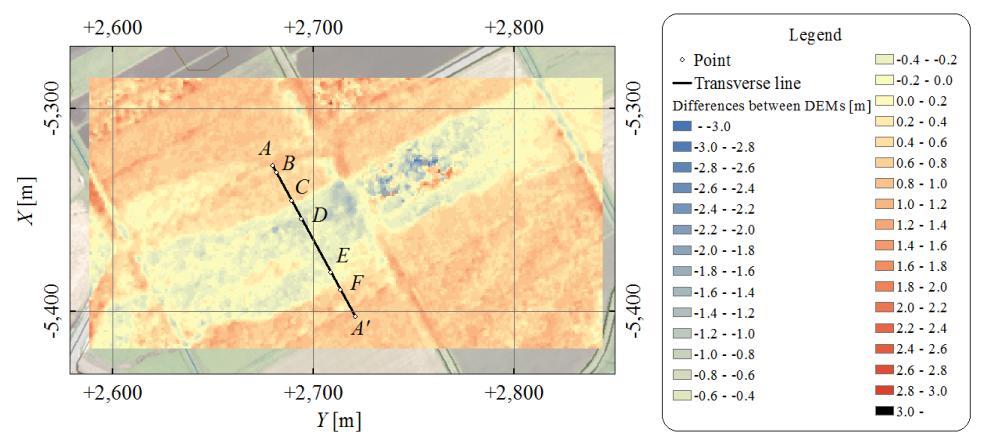
Fig. 8 Differences between the DEMs before and after the earthquakes at the cracks

We found several points where a cave-in could be confirmed by the orthophoto mosaic of Fig. 5, even though it was not possible to detect these when comparing the differences between the DEMs before and after the earthquakes, such as in the rectangle in Fig. 7. The reason for this may be that, although the point caved-in, it underwent upheaval as a whole. For this reason, we compared the DEMs before and after the earthquakes using a lateral profile. Fig. 8 shows the transverse line A-A' used to compare the DEMs before and after the earthquakes. We designated Points B, C, D, E, and F at distances of 4, 20, 30, 60, and 70 m from Point A. This rectangular area is the same as that shown in Fig. 5. Although the earthquakes caused a cave-in, a large difference could not be detected when comparing the DEMs before and after the earthquakes. This is presumably because the overall area underwent upheaval, thus causing a relative cave-in. Fig. 9 shows a cross section along the line A-A'. The section from Point A to Point B is a paved agricultural road, and it underwent upheaval of about 0.9 m as a result of the earthquakes. This upheaval can be observed from Points A to C. However, a sharp cave-in from the level before the earthquakes can be detected from Points C to E. At Point D, where the sharpest cave-in was observed, the height difference was about 2 m from the land surface. It could also be determined that upheaval resumed from Points F to A'. When comparing the DEMs before and after the earthquakes, it was found that the paddy fields had a more irregular elevation profile on the DEM after the earthquakes. This is presumably because the image mapping has a low accuracy in areas with vegetation. As a whole, we successfully clarified the vertical deformation of the cracks on the fault dimensionally and quantitatively.
