# Estimation of Flooded Areas and Water Levels after the Heavy Rain in July 2018 in Okayama

**Abstract** Paddy fields in the Osaka Prefecture were heavily flooded by heavy rain in July 2018 due to levee breaches. To estimate the flooded area and water level, it was necessary to combine aerial- and ground-based surveying. Accordingly, aerial photographs of the flooded area were taken on the day after the heavy rain. In this study, we developed a digital surface model (DSM) of the flooded area using the structure-from-motion (SfM) software, which can produce three-dimensional (3D) models based on multiple aerial photographs and multiple ground control points (GCPs). Using the global navigation satellite system (GNSS), we surveyed the target area to observe the 3D coordinate values of the GCPs. The DSM of the flooded area could be made by the SfM with the aerial photographs and GCPs. The DSM was input into the geographic information system to analyze the flooded area and water level. The water levels were calculated from the differences between the DSM and the digital elevation model (DEM). We used airborne laser surveying to build the DEM because it provides higher accuracy than the

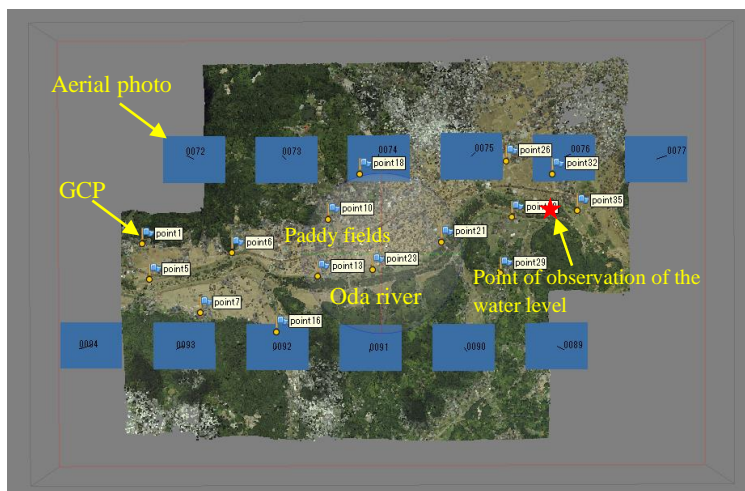
**Fig. 3 3D model by aerial photogrammetry**

shows the 3D model built in this study. The Oda river and paddy fields are in the center of Fig. 3; the point of water level observation, which was performed every hour, is in the right of Fig. 3. The twelve blue rectangles in the sky show the 3D positions from which the aerial photographs were taken. The 15 circles on the ground surface indicate the 3D positions of the GCPs where we conducted the GNSS survey. AS coordinate system, we used the Japanese geodetic datum (JGD) 2011 plane-rectangular coordinate system Area 5 (Matsumura et al., 2004; Tsuji and Matsuzaka, 2004; Imakiire and Hakoïwa, 2004; Geospatial Information Authority of Japan, 2011). We successfully set a group of 3D points on the ground surface through aerial photogrammetry. The aerial photographs were taken at 12:00 on July 9, 2018, immediately after the heavy rain with a well-calibrated digital aerial camera. Using the RTK GNSS surveying and inertial measurement unit (IMU) technology, we set the coordinate axes and altitudes of the digital aerial camera with an accuracy of several tens of millimeters.

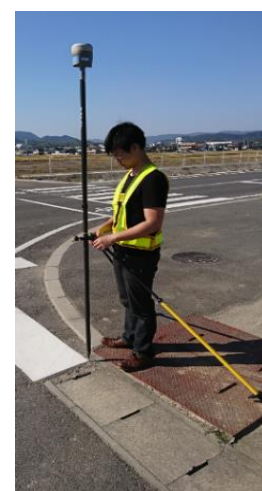
**Fig. 4 GNSS surveying**

As shown in Fig. 4, we conducted a network-based RTK GNSS surveying at GCPs in Okayama on November 10, 2018. We used the Trimble R10 for the GNSS surveying, and three types of satellites: GPS, GLONASS, and the quasi-zenith satellite system (QZSS). In addition, we used two frequency bands: L1 (1575.42 MHz) and L2 (1227.60 MHz). We used the geoid model GSIGEO2011 (Miyahara et al., 2014; Kubodera et al., 2016). For the GNSS survey at the GCPs, we selected the fifteen points enclosing the flooded area and the point of observation of the water level, sites accessible by car, and pavements to obtain clear photographs.

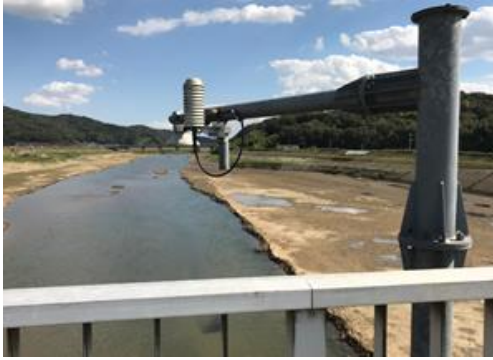
**Fig. 7 The water level observation in Yakatabashi**  
 The first author took the picture on October 29, 2018.

We compared the elevation values of the DSM to those of the actual water surface at the point of water level observation to verify the accuracy of the constructed DSM. Figure 7 shows a photograph of the instrument used to observe the water level in Yakatabashi, which observed the actual water level every hour during the heavy rain in July 2018. The first author took the picture on October 29, 2018. Figure 8 shows the DSM of the area around Yakatabashi. The areas of not-heat-map were those that PhotoScan Professional could not create the DSM.

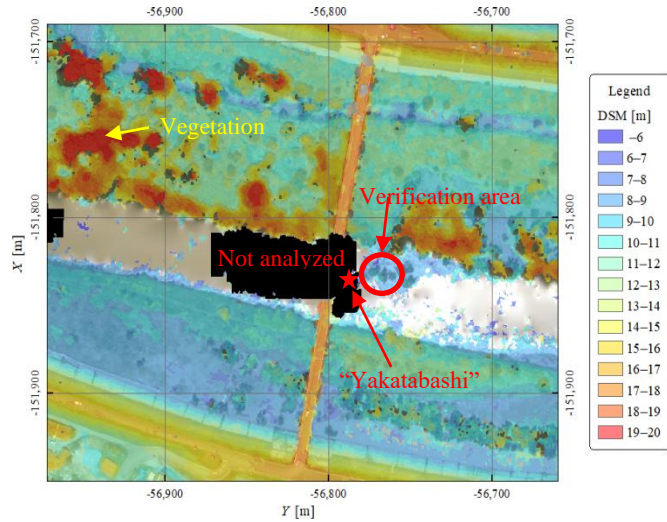
**Fig. 8 DSM around Yakatabashi**

Table 2 shows the elevation values in the DSM around Yakatabashi at 12:00 on July 9, 2018. The aerial photographs were taken at 12:00 on July 9, 2018. So, this DSM was at 12:00 on July 9, 2018. The elevation values of DSM were measured at 10 points in the water surface of the verification area of Fig. 8. The average and SD of the ten elevation values were 8.208 and 0.096 m, respectively. Table 3 shows the elevation values of the actual water surface at Yakatabashi on July 9, 2018. As shown in the table, the elevation values of the actual water surface at 12:00 was 8.167 m. Therefore, the difference between the elevation values of the DSM and those of the actual water surface was  $+0.041 \pm 0.096$  m.
