Research article

Analysis on Surface Deformation and Cracks in Paddy Fields by 2016 Kumamoto Earthquake using GNSS and Photogrammetry

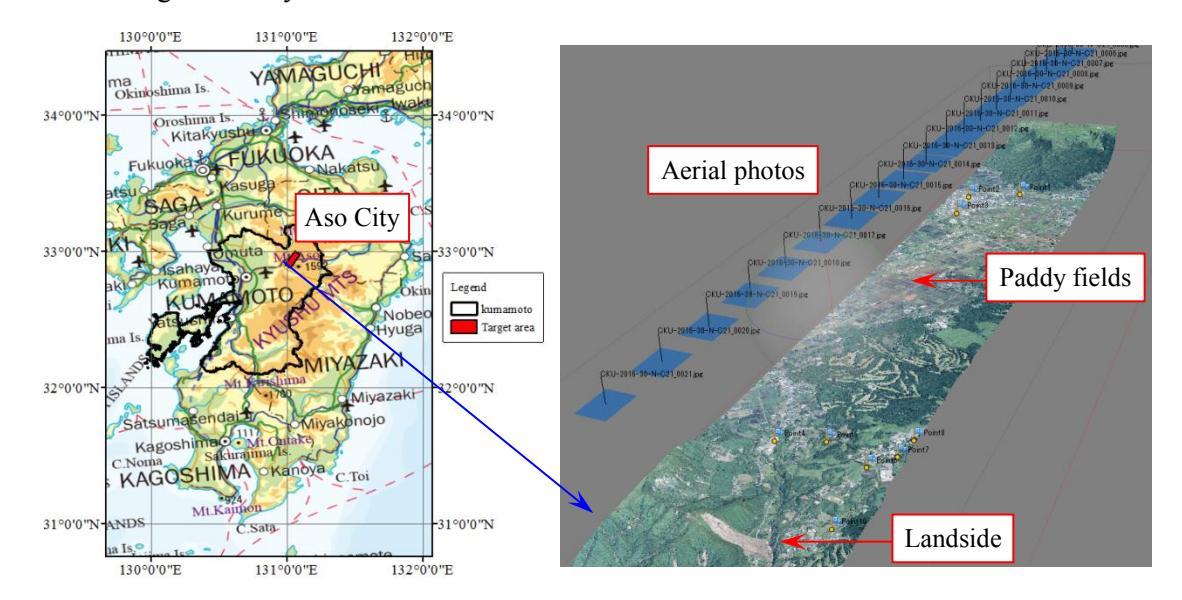
Fig. 1 Target area in Kumamoto

Fig. 2 The 3D model by aerial photogrammetry

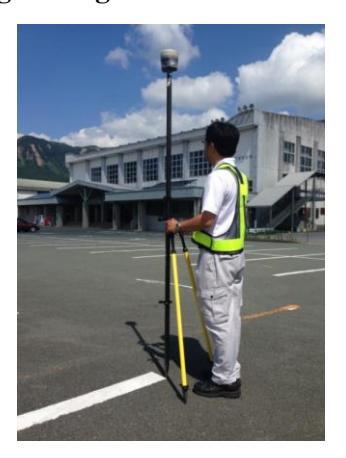
Fig. 3 GNSS surveying

As the photograph in Fig. 3 shows, we conducted a network-based RTK GNSS surveying in Kumamoto on the 23rd and 24th of July 2016. We used the Trimble R10 for the GNSS surveying, and three types of satellite: GPS, GLONASS, and the Quasi-Zenith Satellite System (QZSS). In addition, we used two frequency bands: L1 and L2. The geoid model we used was "GSIGEO2011" (Miyahara el al., 2014; Kubodera el al., 2016). For conducting the GNSS surveying on the ground, we selected the four corners of the course, sites accessible by car, and pavements so that the aerial camera could take clear photographs. Based on the surveying calculations from the GNSS surveying, we found that the standard deviation (SD) of the most probable value was less than 0.01 m. We conducted aerial
